DOCUMENT NO. T5-6539-100

TITLE METALLURGICAL ANALYSIS OF A 504 VEHICLE OXIDIZER TANK  
RING BAFFLE WEB, 60B12550-1 FAILURE

MODEL NO. Saturn V/S-IC CONTRACT NO. NAS8-5608

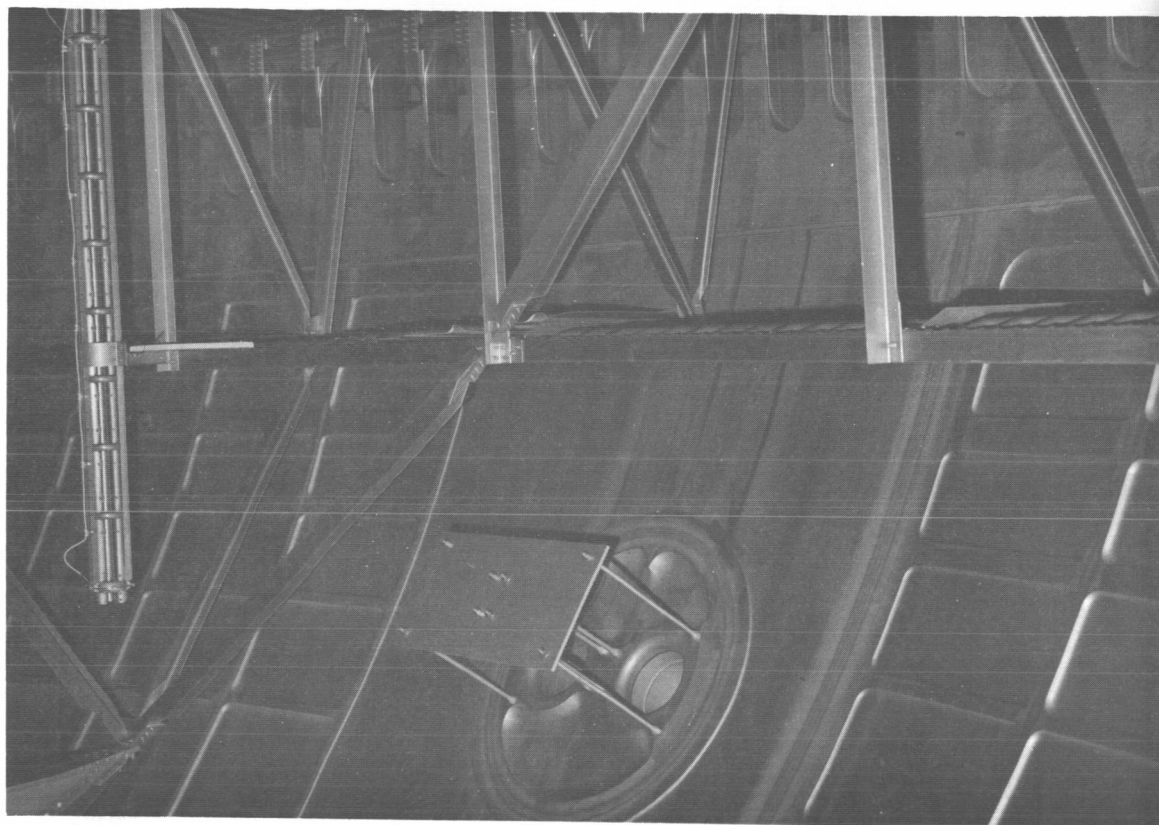
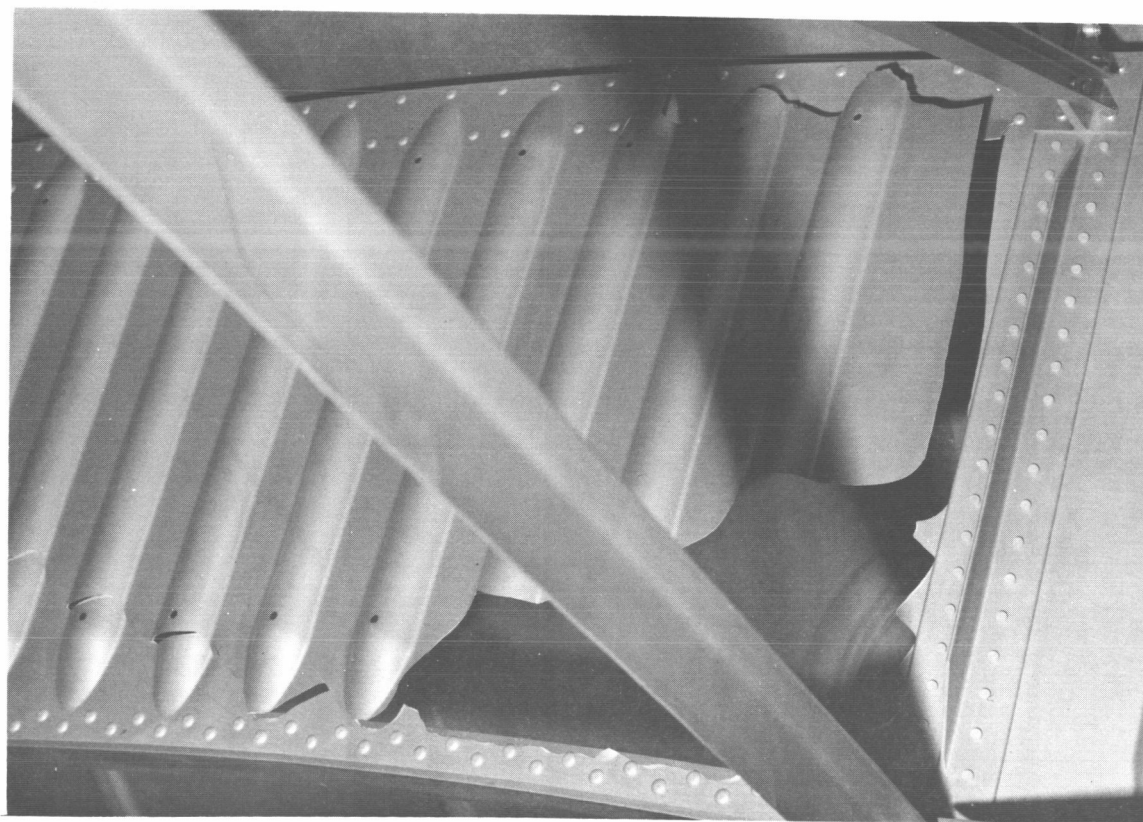
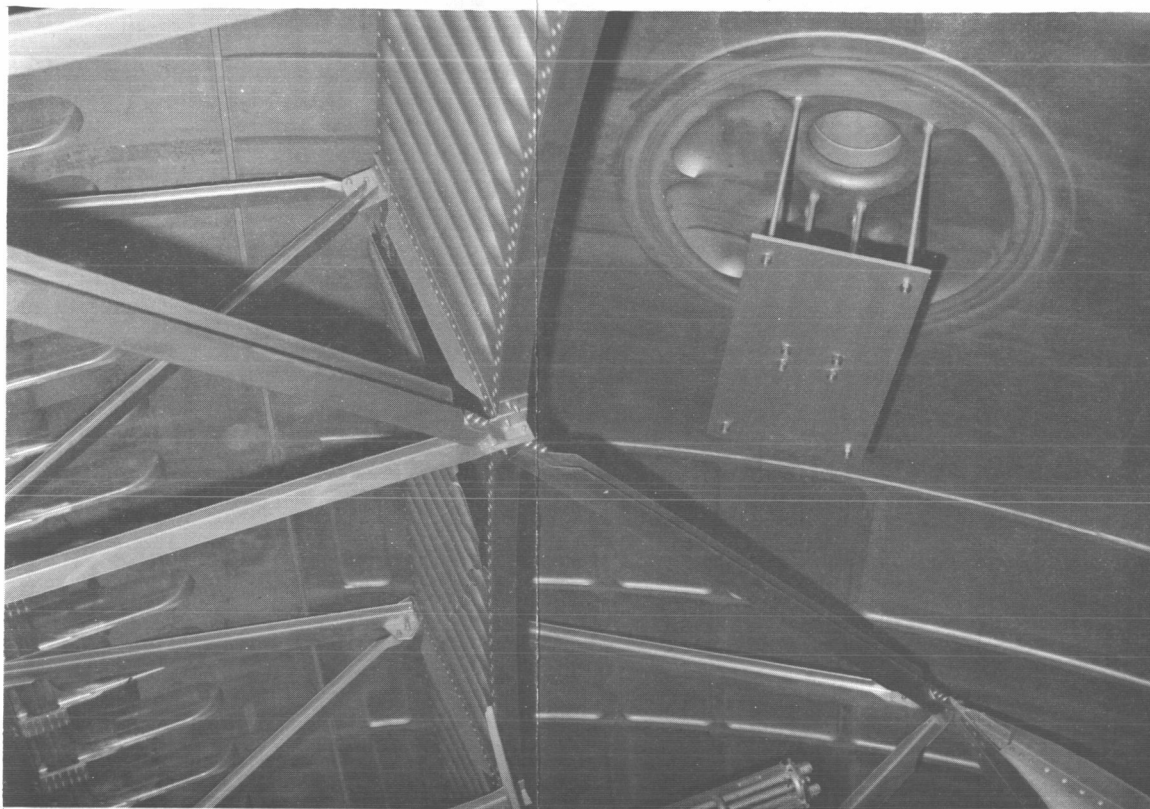
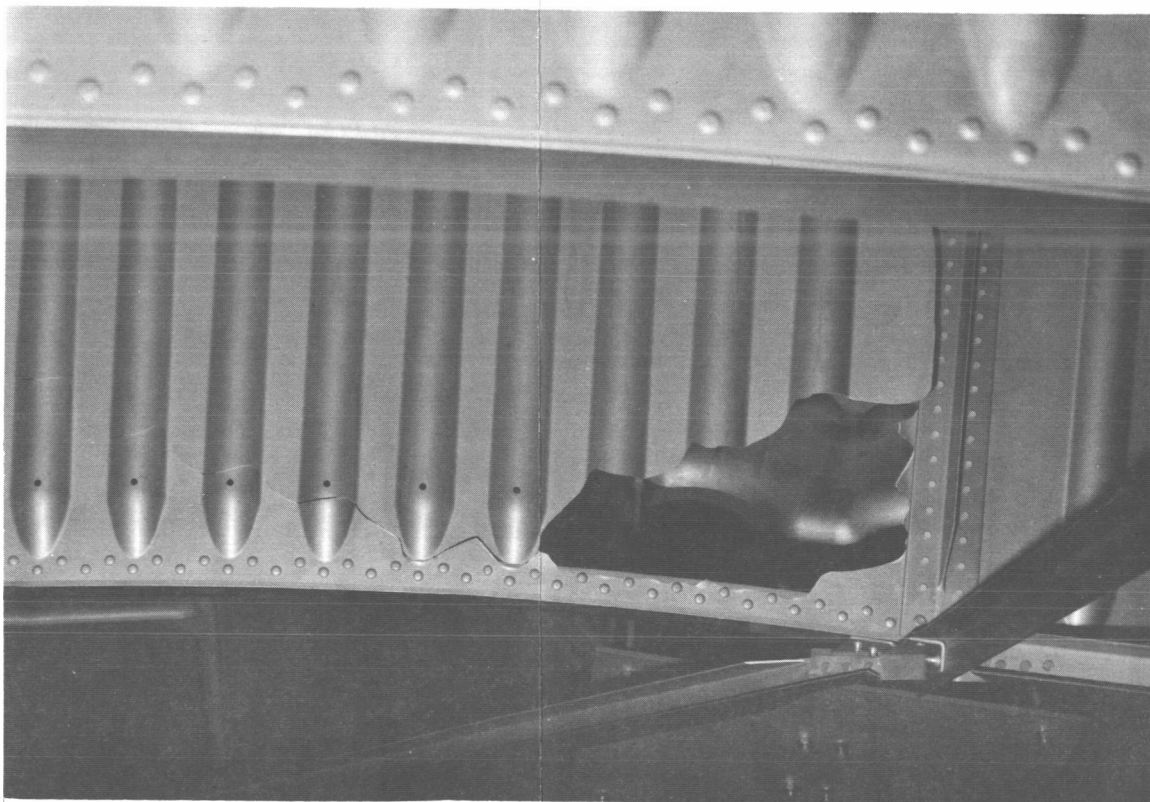
FIGURE 1 - FAILED RING BAFFLE WEB INSTALLED IN OXIDIZER TANK

Post static firing inspection of the 504 vehicle revealed the failure of an Oxidizer Tank Ring Baffle Web, 60B12550-1. Unplanned Event Record U272347, July 15, 1967, reported a hole found in a ring baffle segment located in the first ring baffle at Position II of the lower bulkhead. Figure 1 shows four views of the installed web upon discovery of failure. It is noted that the failure occurred adjacent to the liquid oxygen fill and drain port. It appears that a portion of the entering liquid oxygen impinged upon the fractured web.

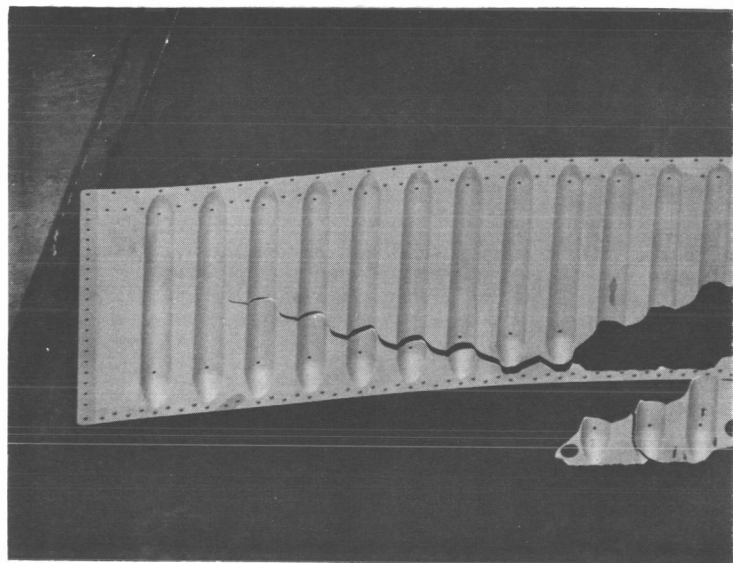
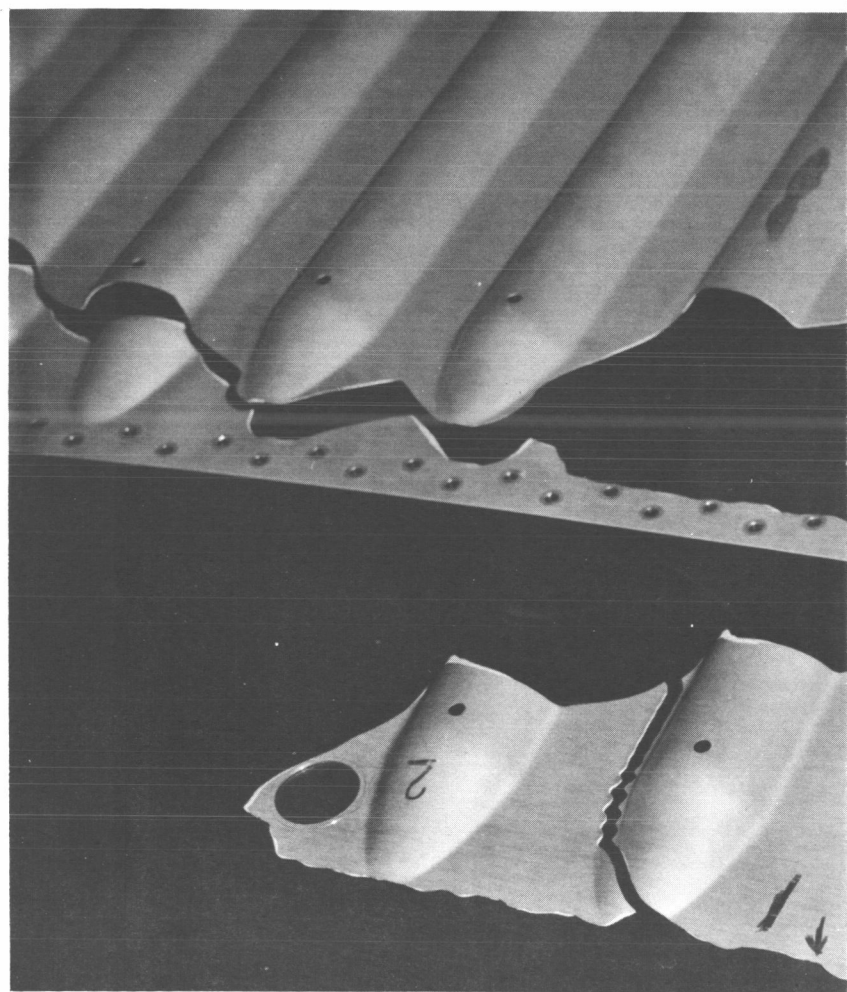
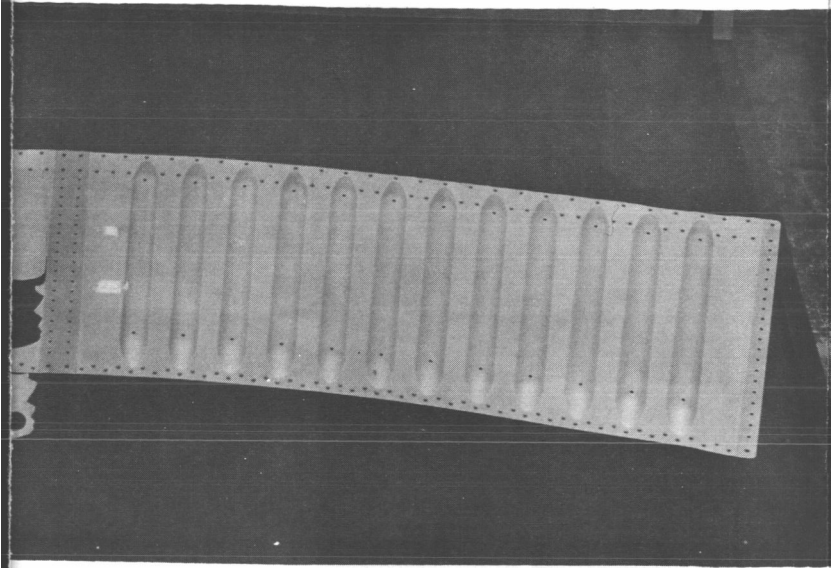
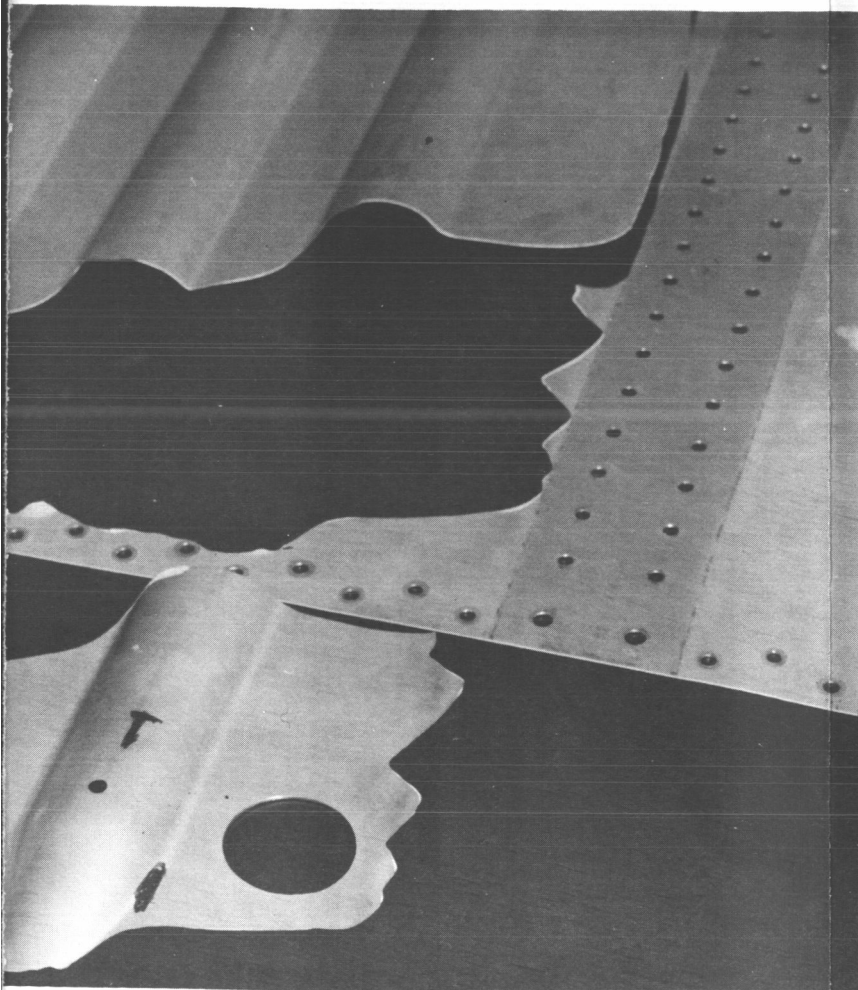
FIGURE 3 - FAILED WEB AS RECEIVED IN LABORATORY

- 5.2 The failed part as received in the laboratory is shown in figure 3. The failure was such that two pieces were broken out from the web. The holes seen in both pieces are where samples for chemical analysis were removed. Figure 4 shows the convex and concave sides of these two pieces. The region marked is the major area of interest in fractographic analysis. The fracture surfaces were examined visually and under low magnification. The primary initiation point of failure is indicated in figures 3 and 4, by an arrow. However there are indications of fracture initiation at five locations. All initiation points are adjacent to rivet holes along the inboard edge of the web. None were through rivet holes, but at the contact point of the rivet head. Figure 5 shows four fractographs near the primary failure origin. Views A and D indicate that initiation was between these points, while the fracture pattern is characteristic of a tensile failure. Views B and C, directly adjacent to the initiation area, exhibit a fatigue type fracture pattern. Figure 6 shows the two opposite fracture faces at the primary origin, also exhibiting a fatigue mechanism. The combination of fatigue and tensile fractures observed in the fractographs indicates that failure resulted both from high cycle, low load fatigue and low cycle, high load fatigue mechanisms. Electron fractographs taken at the primary failure origin are shown in figures 7 and 8. The fracture mode was found to be intergranular, characteristic of stress corrosion cracking in aluminum alloy 7079-T6. The region of intergranular cracking observed is quite small, but could have acted as an initiation site for fatigue inception.

Note: Material removed from  
sections 1 and 2 for  
chemical analysis

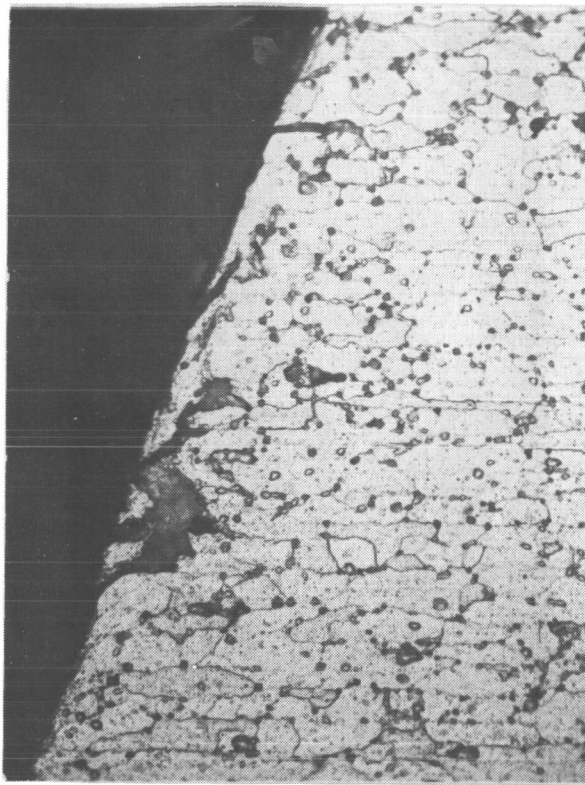
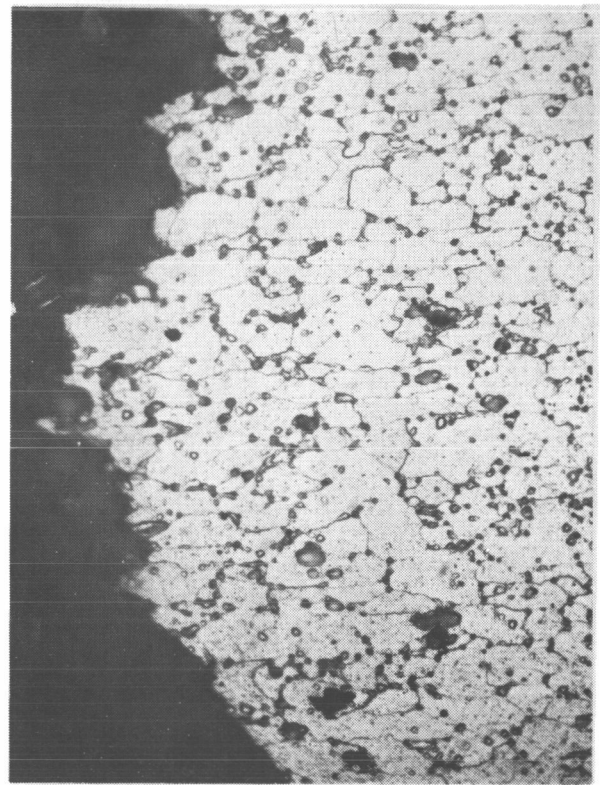
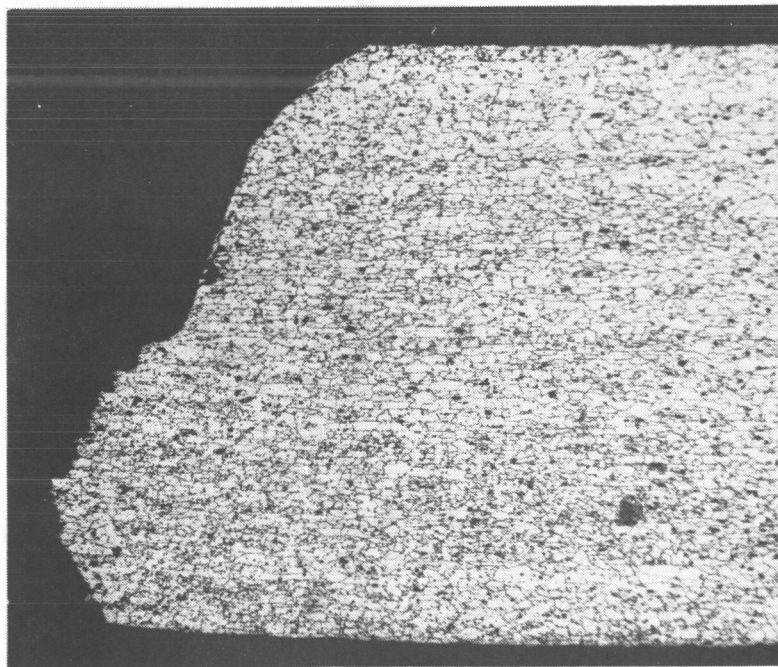
Figure 9 - Microstructure of web near the primary fracture origin. Keller's Etch

The results of microscopic examination revealed a normal microstructure for 7079-T6 aluminum alloy sheet. Cross section views near the first three origin points are shown in figures 9, 10 and 11. The failure mode is both transgranular and intergranular. The isolated areas of intergranular cracking confirm that stress corrosion cracking existed near rivet holes.
